**SUBJECT: VOLUNTARY CLEANUP PROGRAM (VCP)
CES GRIGGS ROAD VCP SITE
4900 GRIGGS ROAD, 4904 GRIGGS ROAD, AND 5910 WAYLAND STREET
(VCP No. 2751; CN604824904; RN108370644)**

MONTHLY STATUS REPORT: JUNE 2016

Figure 1
GROUNDWATER GRADIENT MAP
JUNE 7, 2016

COC CONCENTRATION MAP

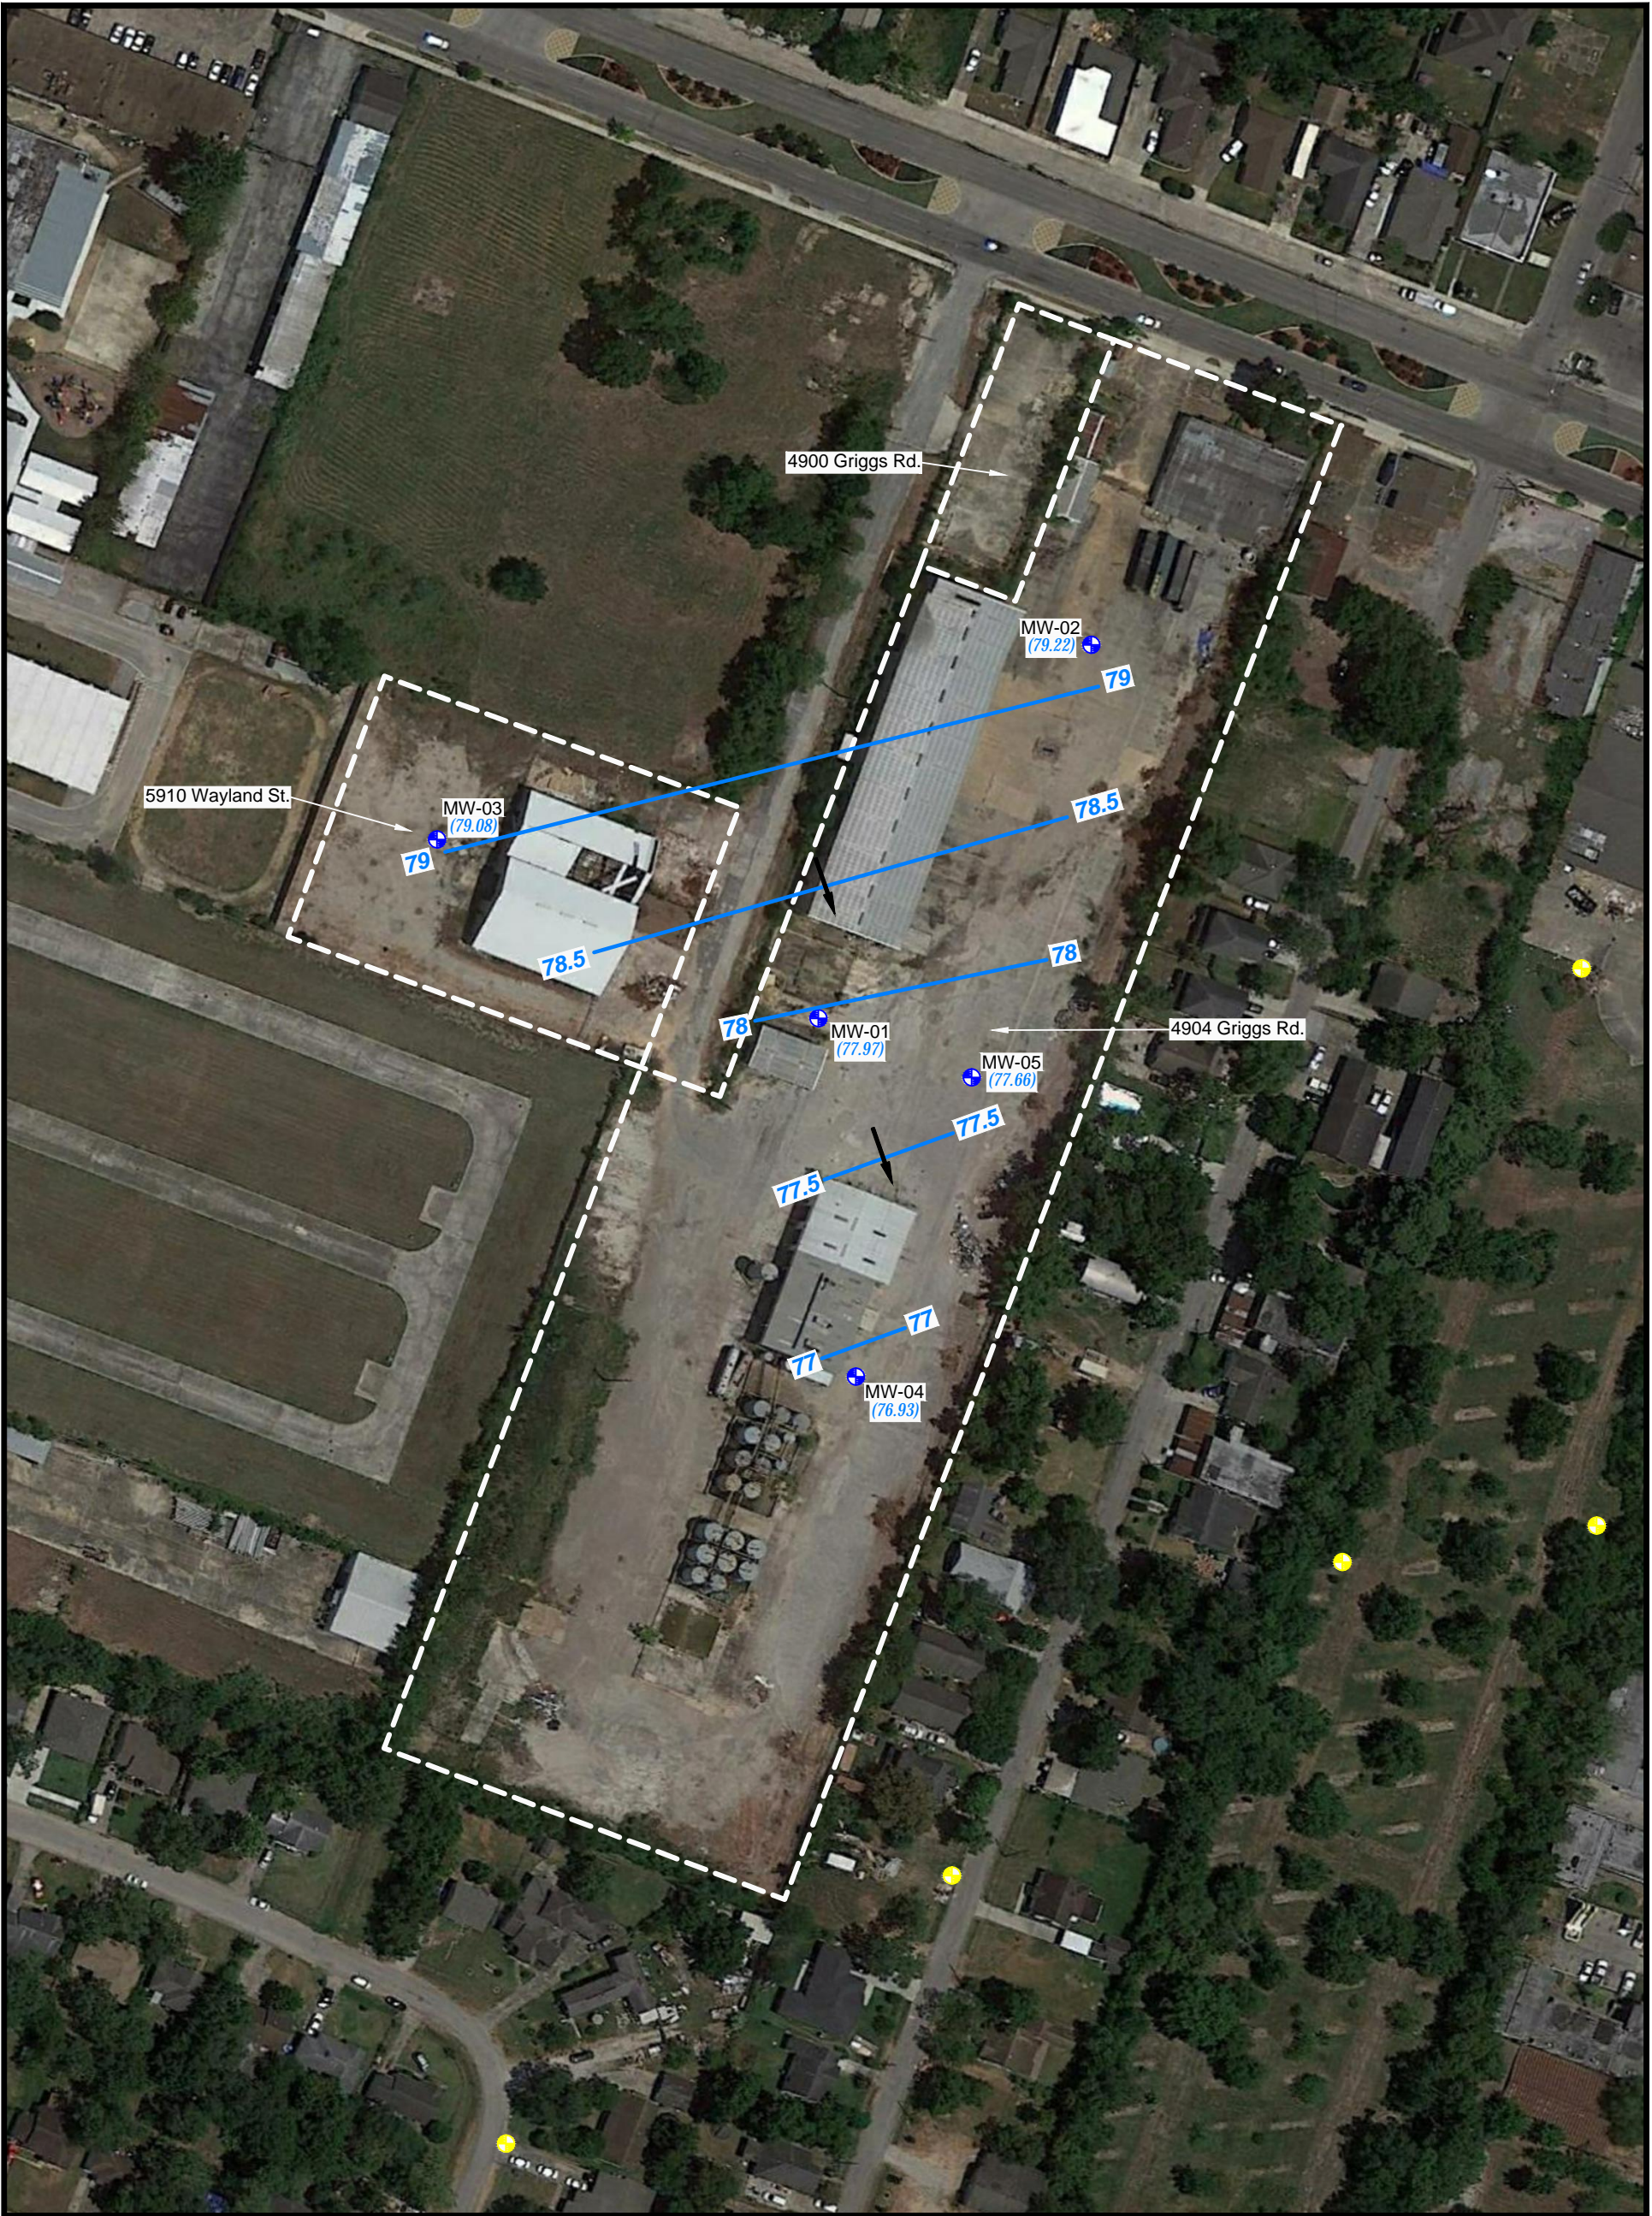
1. Performed quarterly groundwater sampling. Attached are figures that show the June 2016 groundwater gradient and the February and June 2016 analytical results from seasonal groundwater sampling events. As shown on the figure, constituents in groundwater decrease significantly a short distance down gradient of the presumed source area (i.e. MW-1). All constituents in the most down gradient well (MW-4) on site were below drinking water standards.
